Monitoring Data Record

Project Title: Henderson Western Loop (U-2527) COE Action ID: 199708127

Stream Name: UT to Red Bud Creek DWQ Number: 031494

City, County and other Location Information: Henderson, Vance County
(Sta. 40+80 to 47+20)

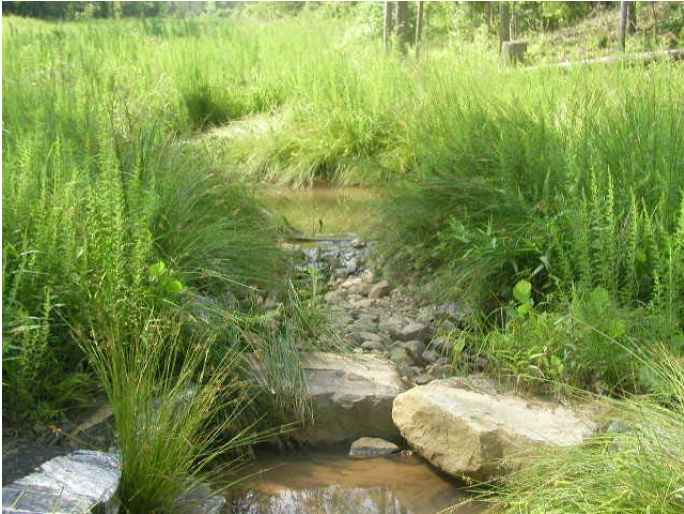
Crossvane @ Sta. 41+00

The stream is highly stabilized for the first year of monitoring. There is some minor bank erosion at approx. Sta. 40+90 but this area is stabilized with heavy herbaceous vegetation. According to the plan sheets it looks like the old channel was located in this area. The crossvane located at approx. Sta. 41+00 has water piping under the structure. The additional photo located at the end of the photo sequence shows this crossvane is still intact and no immediate corrective action is necessary.

Date Inspected	Sta. 40+90	Sta. 41+00	Station Number	Station Number	Station Number
Structure Type		Crossvane			
Is water piping through or around structure?		Water is piping under crossvane			
Head cut or down cut present?					
Bank or scour erosion present?	Minor Bank Erosion				
Other problems noted?
